Vehicle : MERCEDES BENZ E300

Chassis number : W1K2130536L035745

Inspection date : 2024-07-24

Vehicle Certification : Pass the inspection standard of SCHIC INSPECTION BY LEMON-AIDE

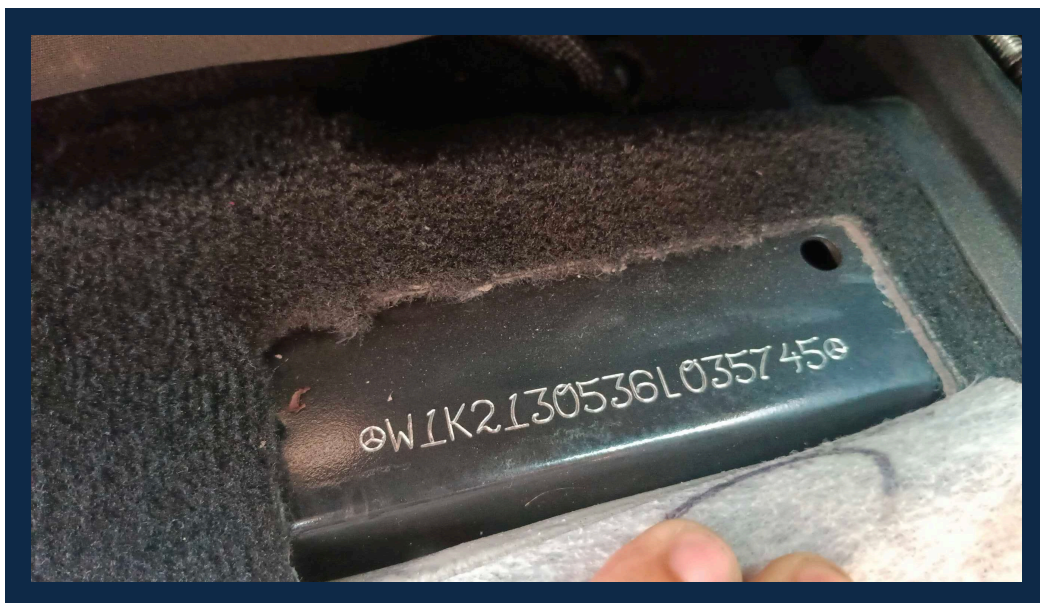
Vehicle Chassis Image

No dent in the under carriage (th)	PASS
No deform chassis or chassis frame (th)	PASS
No visible corrosion on the chassis or chassis frame (th)	PASS
No missing part on the chassis frame (th)	PASS
Half cut Analysis (th)	PASS

Chassis Damage Level	No Damage
----------------------	-----------
