Preowned Vehicle Inspection Report

Premium Inspection Analysis

Vehicle : MERCEDES BENZ GLC220

Inspection date : 2024-08-08

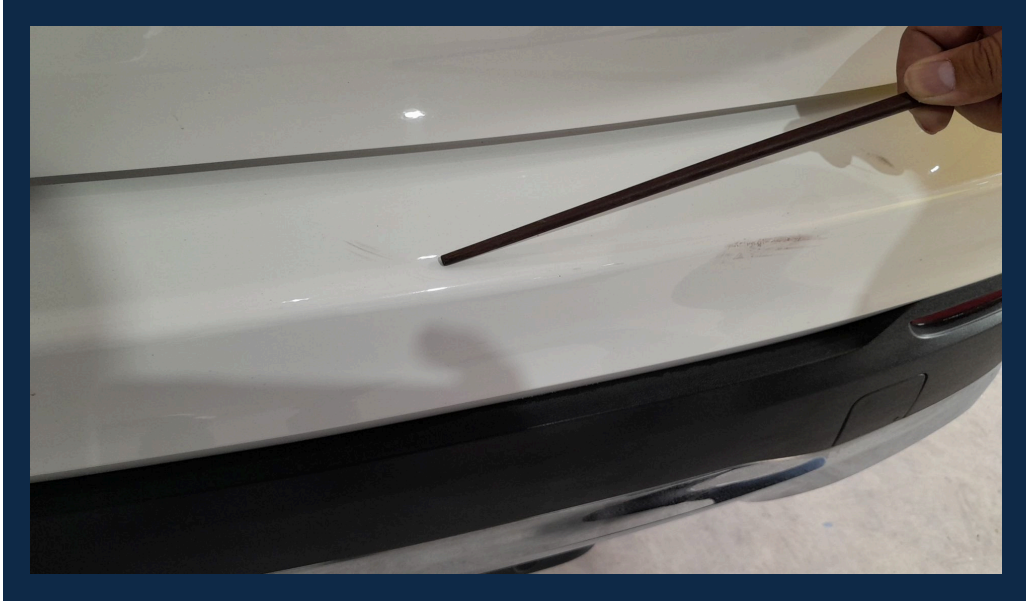
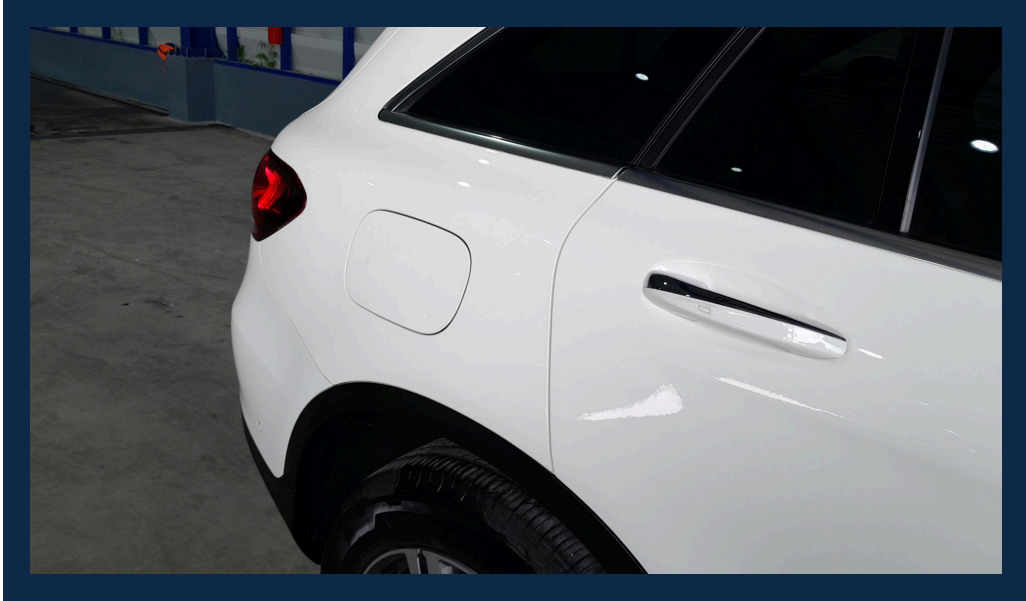
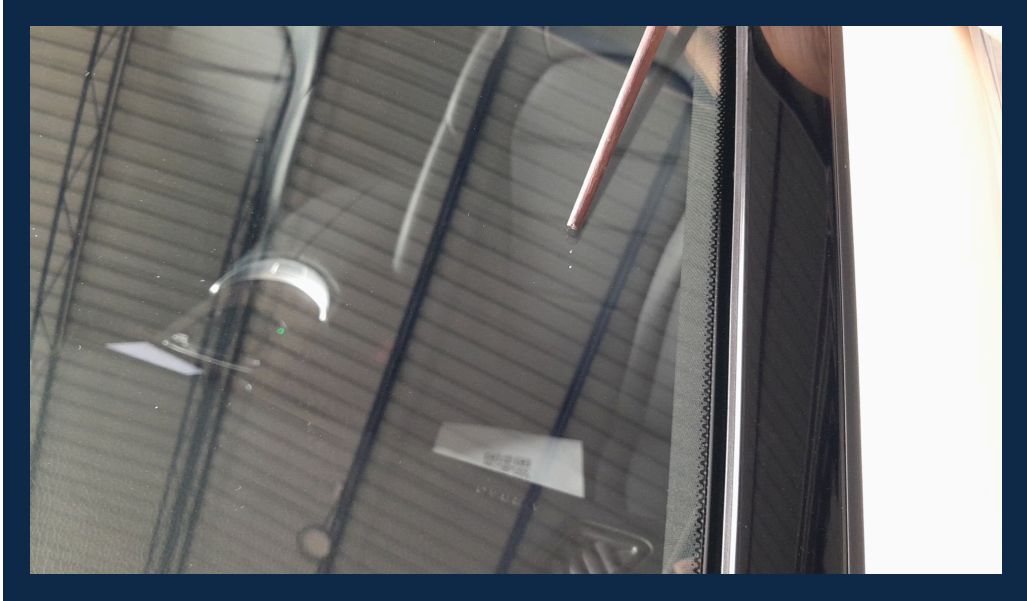
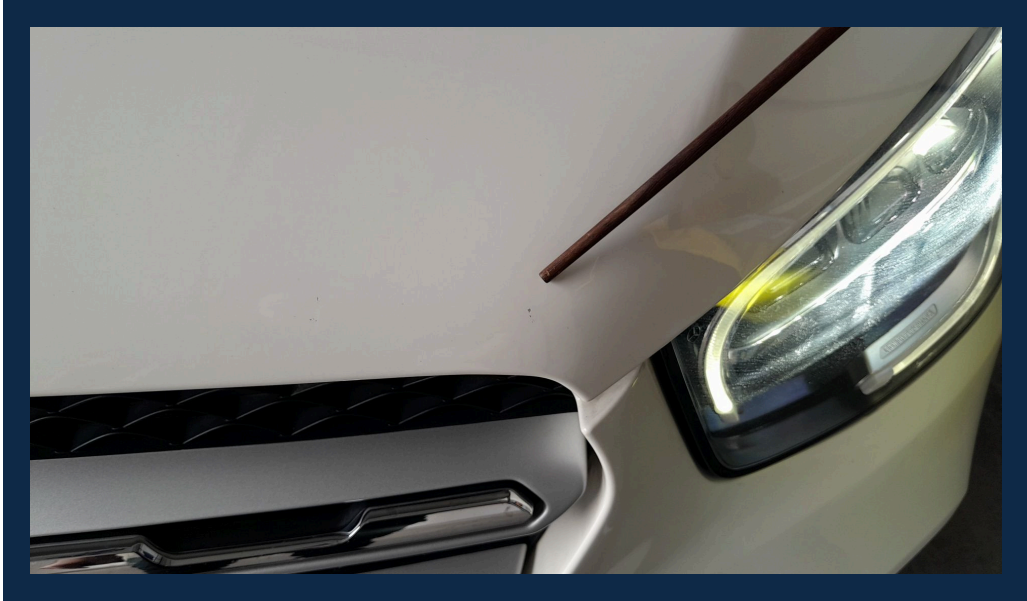
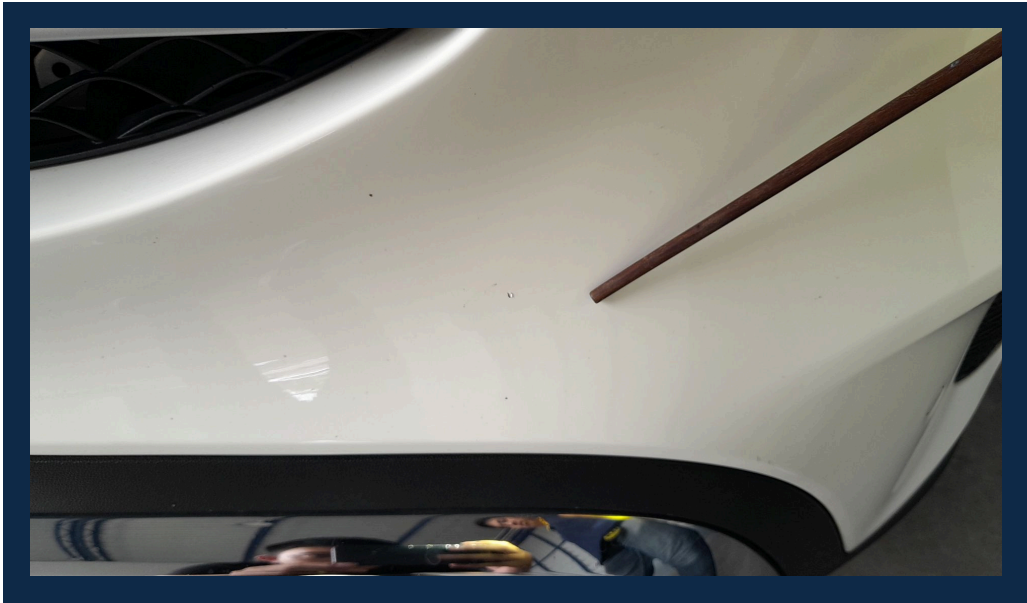
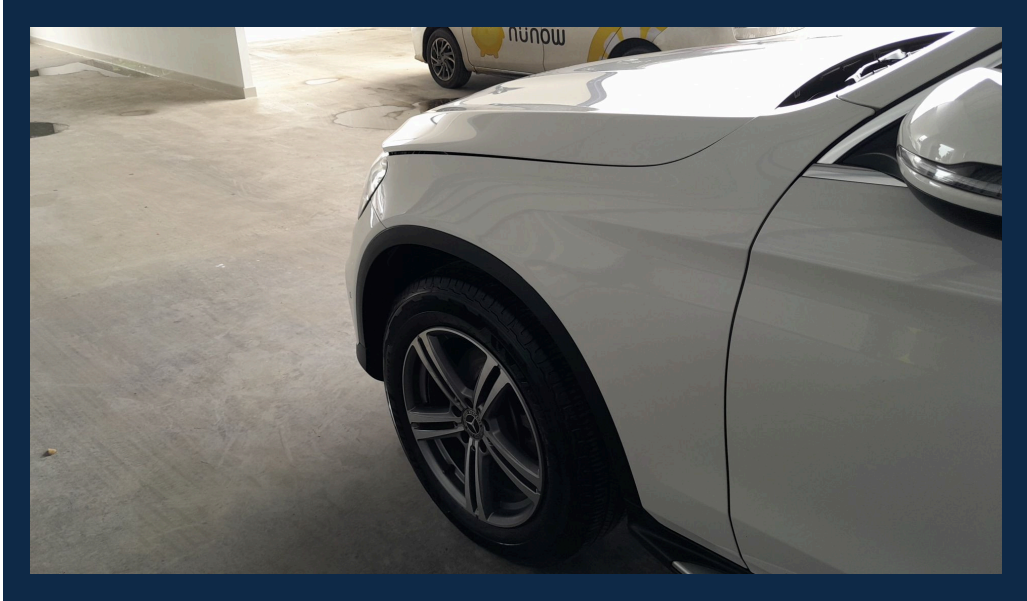
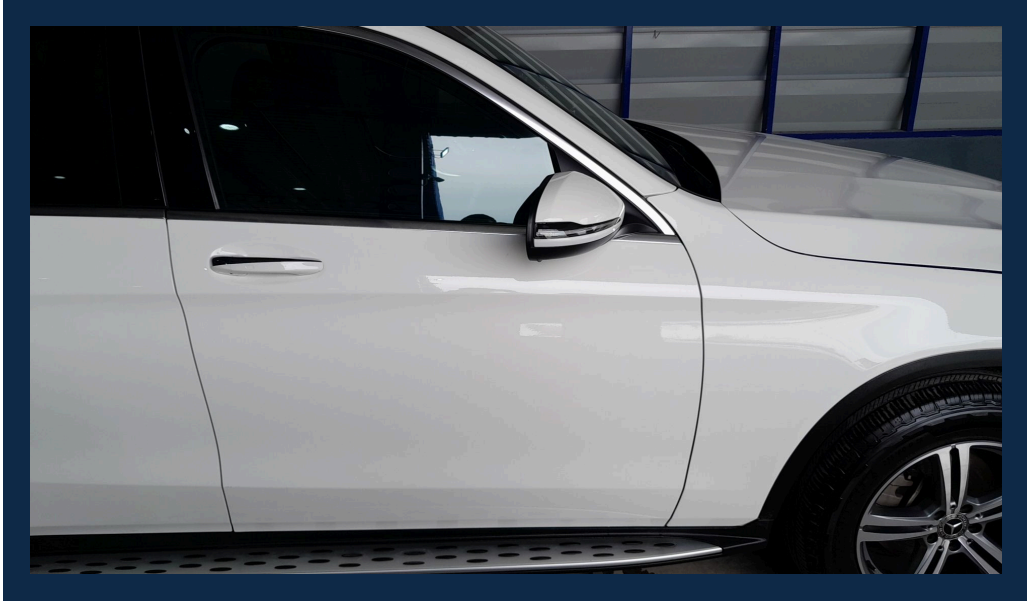
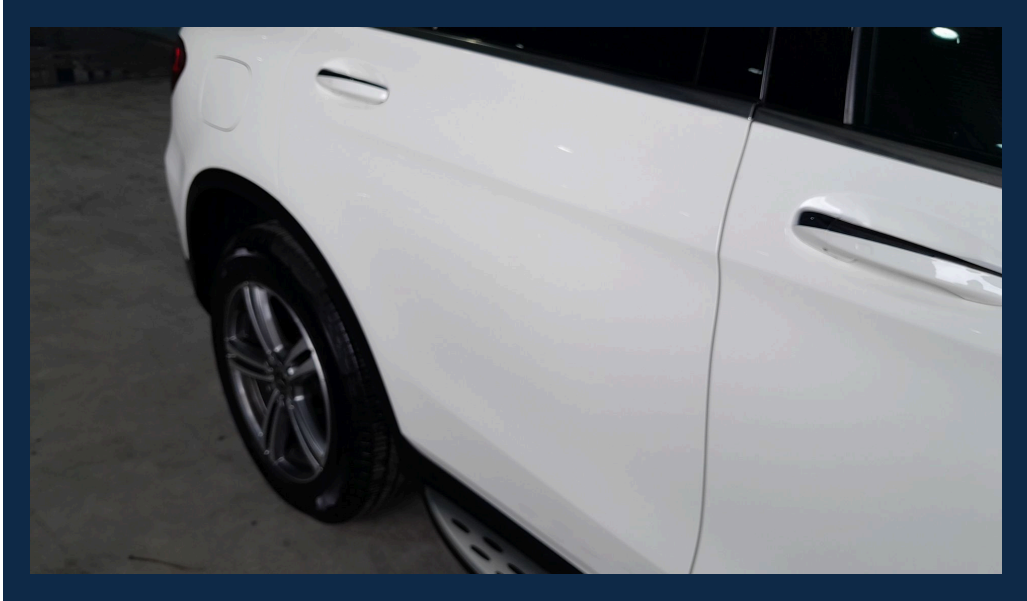
Vehicle Defect Notices

1. Front Skirt	O	14. Left Skirt	O
2. Front Bumper	O (S1)	15. Left Wing Mirror	O
3. Front Right Fender	O	16. Front windshield	O (G1)
4. Front Right Wheel	O	17. Roof	O
5. Front Left Fender	BP	18. Rear right fender	BP
6. Front Left Wheel	O	19. Rear Bonnet	O
7. Front bonnet	O (S1)	20. Back Right Wheel	O
8. Right Wing Mirror	O	21. Rear Bumper	BP (S1)
9. Front right door	BP	22. Rear Skirt	O
10. Rear right door	BP	23. Rear Left Fender	O
11. Right Skirt	O	24. Back Left Wheel	O
12. Rear Left Door	O	25. Back Windshield	O
13. Front Left Door	O
