Preowned Vehicle Inspection Report

Premium Inspection Analysis

Customer Name	: MERCEDES-BENZ MOBILITY (THAILAND) CO., LTD.	Inspection Date	: 2024-09-18
Tel.	:	Lemon Inspection ID	: LEMON24090171
Inspector	: ไชยมงคล ไพโรเลี้ยง	Approved By	: Sakulpong S

Brand	MERCEDES BENZ	Model year	2022
Model	C220	Engine Code - No.	65482080041496
Sub-model	d Avantgarde	Registration year	2023-06-28
License Plate		Chassis No.	W1K2060046L002615
Current Mileage(km.)	24497	Engine Capacity(cc.)	2000

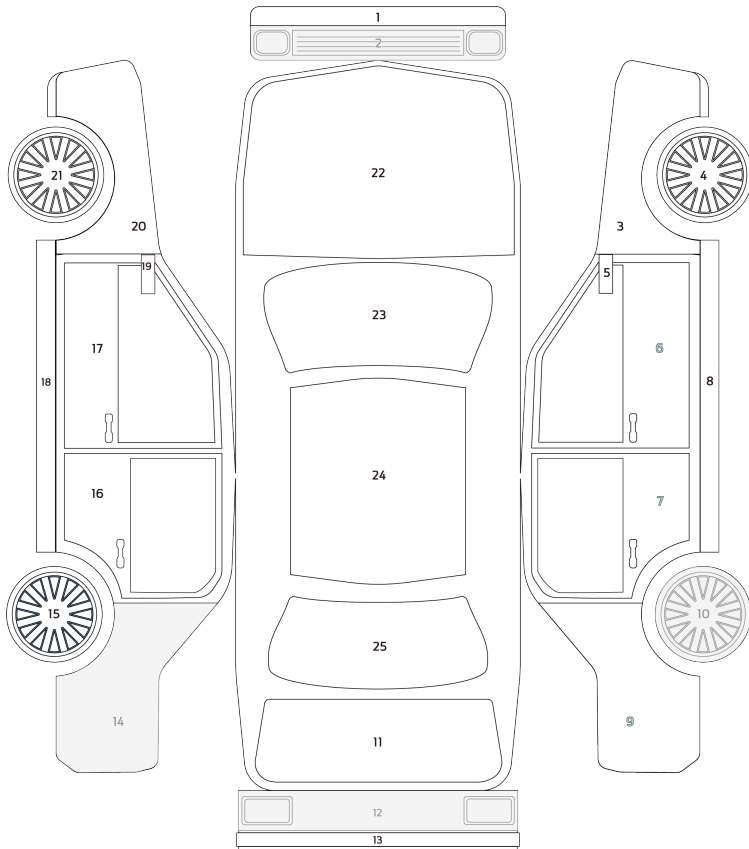
Exterior Inspection Points

1. Front Skirt	O	14. Left Skirt	O
2. Front Bumper	O (S1)	15. Left Wing Mirror	O
3. Front Right Fender	O	16. Front Windshield	O
4. Front Right Wheel	O	17. Roof	O
5. Front Left Fender	O	18. Rear Right Fender	O
6. Front Left Wheel	O	19. Rear Bonnet	O
7. Front Bonnet	O	20. Back right wheel	O (S2)
8. Right Wing Mirror	O	21. Rear Bumper	O (S2)
9. Front Right Door	O	22. Rear Skirt	O
10. Rear Right Door	O	23. Rear left fender	O (S2)
11. Right Skirt	O	24. Back Left Wheel	O
12. Rear Left Door	O	25. Back Windshield	O
13. Front Left Door	O
